# The role of winding pattern on filament wound composite cylinders under radial compression

## Abstract

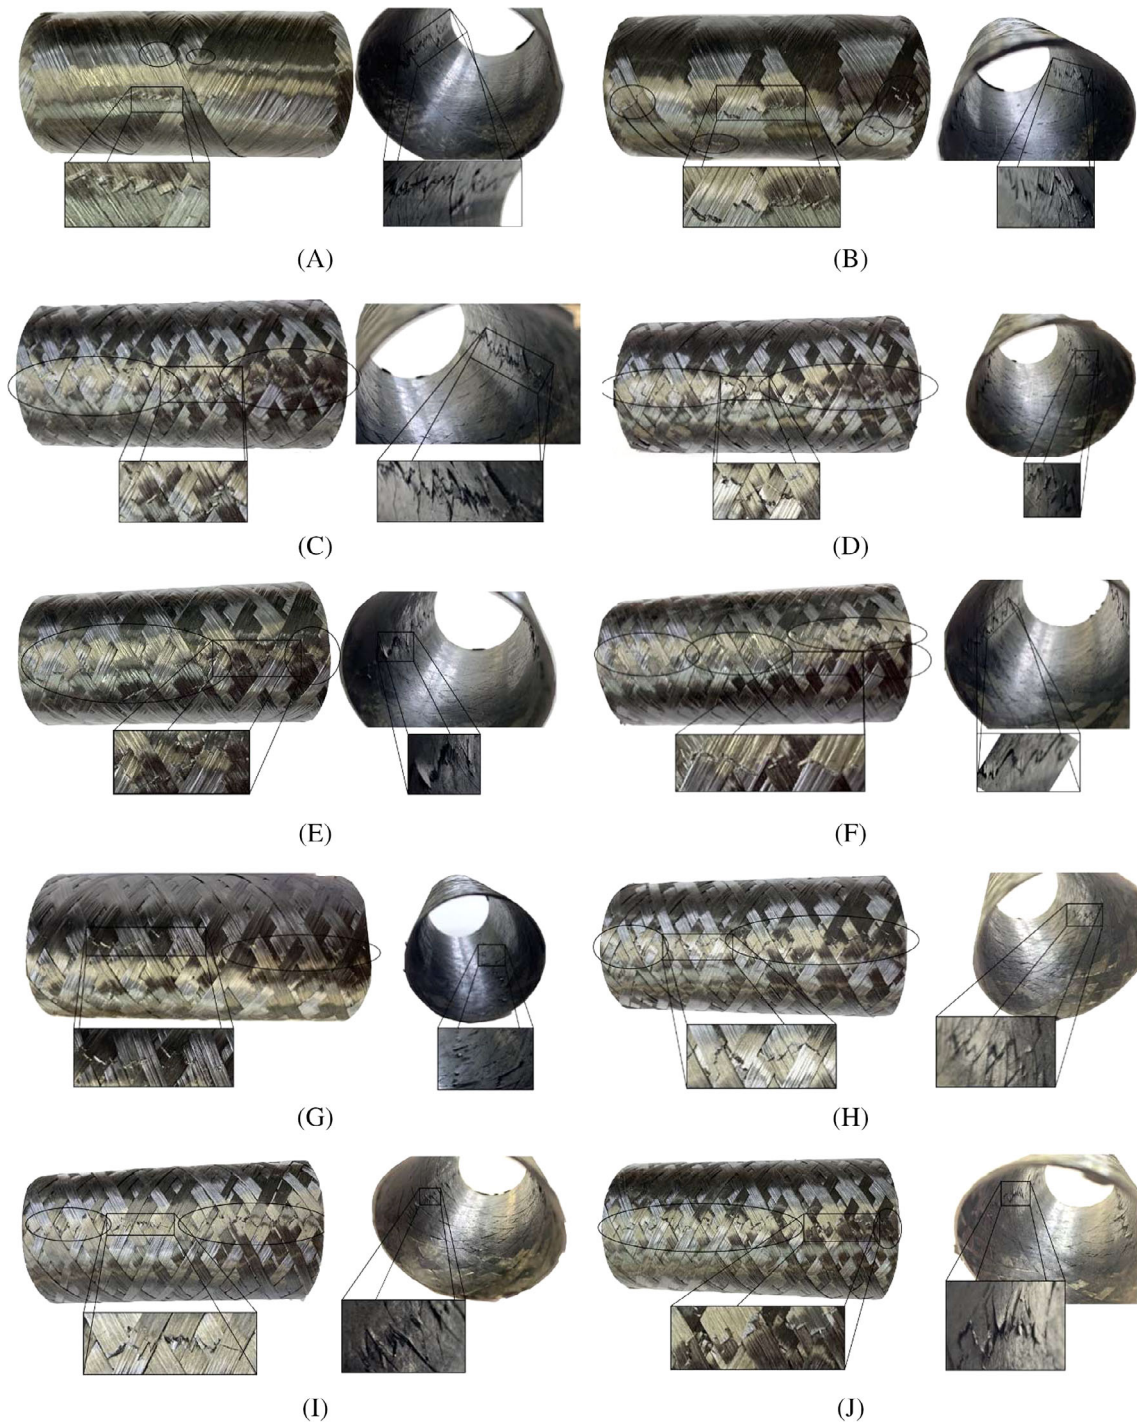
Figure 3A–J show outer and inner surfaces of typical specimens after testing, along with some details of the failure. There are some differences in the outer failure surface for the various patterns, but the inner surface (the region located 90° from the center of the plate's loading) is similar. Based on curved beam theory, maximum bending stress (compressive) occurs at the inner surface leading to catastrophic failure (see Figure 2). The noticeable damage in the outer surface is a result of the loading

**FIGURE 3** Fractured specimens with winding pattern of: A: 1/1; B: 2/1; C: 3/1; D: 4/1; E: 5/1; F: 6/1; G: 7/1; H: 8/1; I: 9/1; and J: 10/1 [Color figure can be viewed at [wileyonlinelibrary.com](http://wileyonlinelibrary.com)]

from the applied stress and the friction with the loading plates, which helps explaining the lateral spread in some patterns (eg, Figure 3E,F).

It is worth noticing that crack propagation does not follow a “straight” line, which would be expected for isotropic materials. In both internal and external surfaces, crack propagates parallel to the boundaries of the tows or perpendicular to it (inside a particular tow). For that reason, the propagation of the crack has a “zig-zag” shape, which is best observed at the internal surface (details in Figure 3).
