Research Article

Investigation of the Potential for Evaluation of Concrete Flaws Using Nondestructive Testing Methods

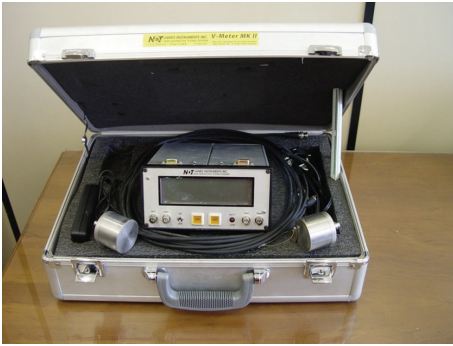
FIGURE 1: Portable ultrasound model V-METER.

A beam was tested with a portable ultrasound model V-METER and James Concrete Test Hammer (Figures 1 and 2). This period was chosen to minimize the influence of concrete strength variation on the measurements. The size of the objects placed inside the beam varied between 30 and 95 mm. All objects were detected by NDT measurements. The V-METER is widely used and accepted for concrete quality

control and inspection. It measures and correlates concrete strength to a standard strength measurement, allowing non-destructive testing of complete structures [8]. The James Concrete Test Hammer is an advanced, completely automated system for estimating concrete compressive strength. Its calculation, memory, and recording functions allow for quick, easy, and accurate test results. They indicate the compressive strength of hardened concrete [13].

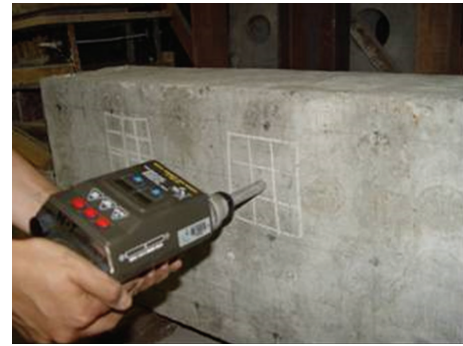
FIGURE 2: Rebound hammer at concrete beam.

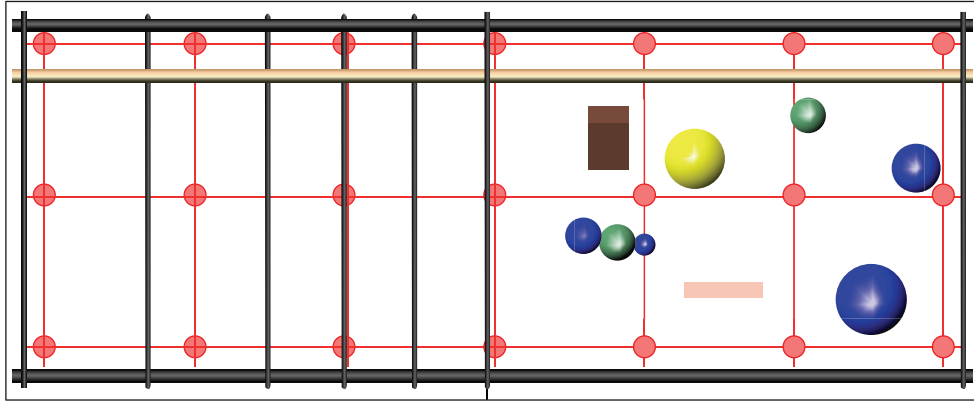
FIGURE 3: Location of the objects into the beam.

In order to investigate which methods were more accurate to detect the objects inside the concrete beam, one grid was tested. Figure 3 shows one of the faces of the grid. Readings were made around each point. The readings were grouped and generated the reading quadrants. The main issue was to determine the best strategy to organize and to interpret ultrasonic pulse velocity results and rebound hammer results. The software program Surfer 7.0 was used to create a superficial map, with an image generation. Figure 4 shows the beam prepared for performance of the ultrasonic tests. A measurement answer sheet was used to ensure the perfect positioning of the transducers during the tests.

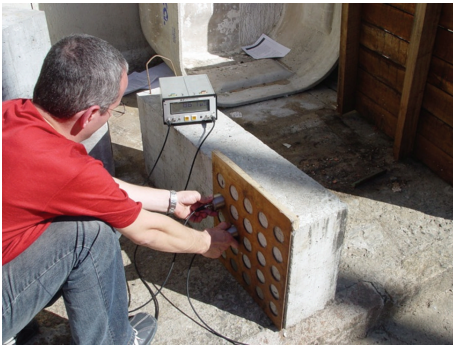
FIGURE 4: UPV measurements at the beam.

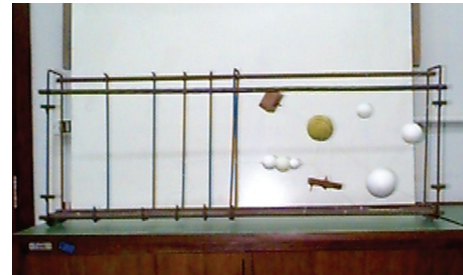
FIGURE 6: Lateral view of the rebar and the objects used to induce defects in the beam.

The elements are shown in Figures 5 and 6. They were kept in place using nylon threads. Reinforcement bars were placed inside the beam to check if their presence would influence the UPV readings. Figure 6 shows a lateral view of the prototype beam with all objects positioned with the aid of nylon threads. One year after being built, the beam was tested.

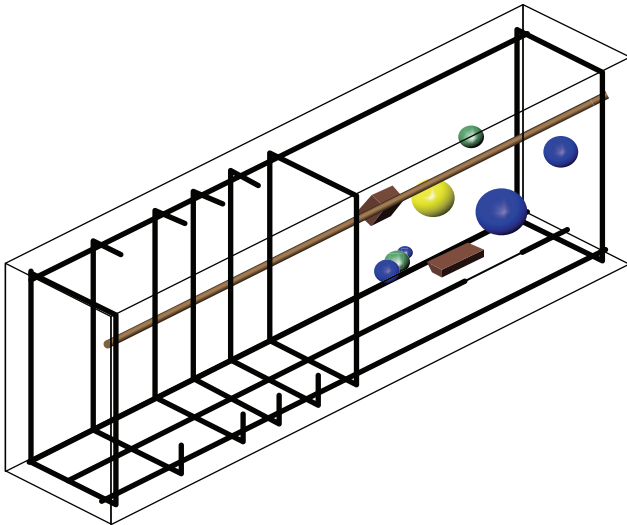
FIGURE 5: Simulation of situations inside the beam.

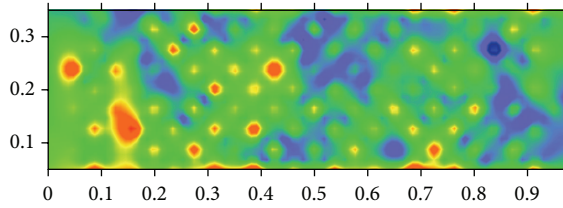
FIGURE 7: View of UPV results at beam—Side A.

5.1. Analysis of UPV Test Results. Figures 7, 8, and 9 present the surfaces generated from the UPV tests. The image analysis clearly shows the regions where the readings are lower or higher than the average. The surface generated by the Surfer software program shows the variations in concrete homogeneity, determining the regions inside the beam presenting differences in homogeneity.

The analysis of the surface contour maps created using UPV data indicates that the use of the values obtained by indirect measurements seems to create more accurate images of the known position of the defects. On the other hand, the use of the smaller grid (75×75 mm) resulted in a more irregular image, which is more difficult to interpret, as shown in Figure 7.

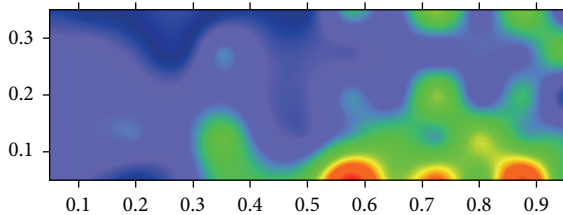
FIGURE 8: View of UPV results at beam—Side A.

were used. Figures 8 and 9 show the images generated with this data corresponding to both sides of the beam. In these images, hotter (red) zones indicate lower UPV values, evidencing the presence of voids or defects. Colder (blue) zones indicate higher UPV values, suggesting more compact zones (or influenced by the presence of the rebar).

In both images, the section of the beam where the defects were induced is clearly identified. The closed loop stirrup in the middle of the beam is also evidenced. The presence of defects or voids that reduce UPV values is unmistakable. The disturbances, as indicated by hotter values, are generally located in the vicinity of the area where the objects were positioned to simulate the concrete defects. It was possible to establish a match between the original position of the defects and the image contour maps.

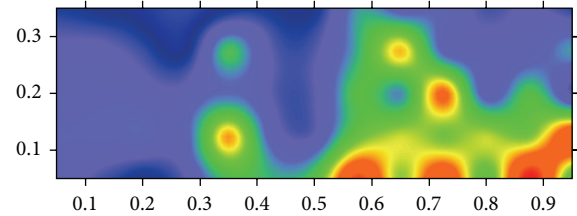
FIGURE 9: View of UPV results at beam—Side B.

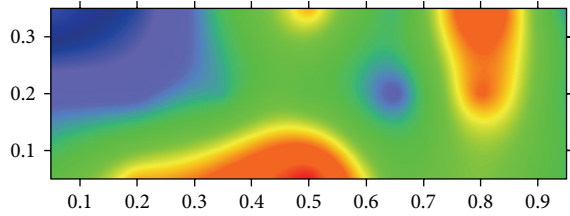
FIGURE 10: View of rebound hammer results at beam—Side A.

5.2. Analysis of Rebound Hammer Results. The rebound hammer results allow generating surfaces that indicates the presence of defects. The obtained results indicate that this test is very useful to locate areas with different concrete surface hardness. With this method, concrete quality in different areas that do not present concrete damage can be compared. However, this method only examines the concrete surface, and therefore its use is relatively limited. The rebound hammer results indicate surface hardness and theoretically seem less capable of detecting the presence of internal defects. Nonetheless, the image contour maps generated with the data collected in these tests are also useful, as shown in Figures 10 and 11.

The hotter colors in the images indicate points of low energy rebounds, suggesting softer or more absorbing surfaces, whereas colder colors indicate high energy rebounds or harder surfaces. The images show that the induced defects were located on the right side of the beams, but the results are less clear than those obtained with the UPV data. A strong rebound signal was recorded where the tennis ball was placed. The signal was stronger on the side B of the beam, consistent with the UPV analysis, which indicated that this ball was probably closer to this side. Also, in agreement with the UPV results, the single table tennis ball was only noticeable in the image of side A. The big Styrofoam ball produced a low rebound signal that was noticeable on both sides of the beam. This signal was stronger in the image of side A and was located immediately below the signal traced back to the table tennis ball.

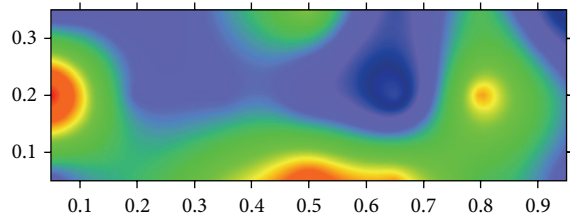
FIGURE 11: View of rebound hammer results at beam—Side A.

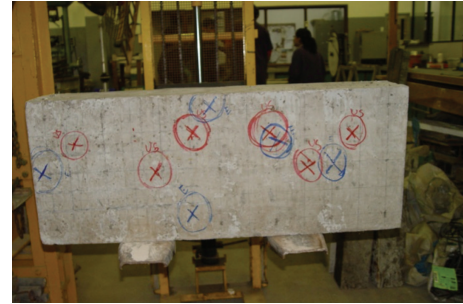
FIGURE 12: Detail of the marked beam.

5.3. Concrete Core Analysis. In order to check if the diagnosis made using the contour map images was reliable, core samples were taken at some points chosen based solely on the contour images. Figures 12, 13, 14, 15, and 16 show the extraction results. Figure 12 shows the beam marked with the extraction points. Red circles indicate UPV suspect points, while blue circles indicate RH points. Figures 13, 14, 15, and 16 show some of the extracted cores, providing clear evidence that the defects were accurately located using only NDT data, with no prior knowledge of their position.

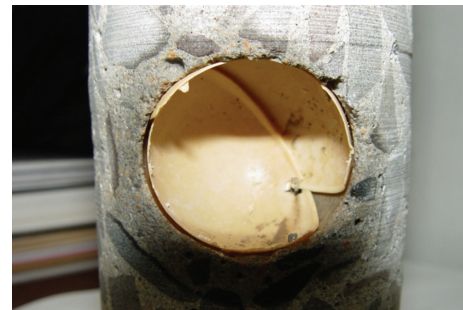
FIGURE 13: Core samples showing the table tennis ball.

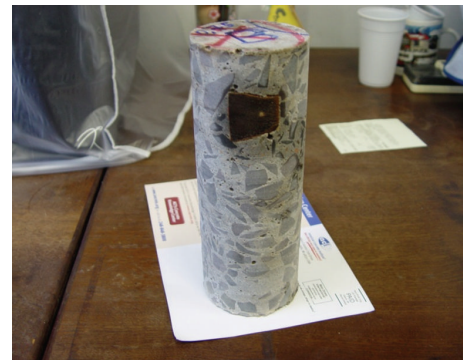
FIGURE 14: Core samples showing the small piece of wood.

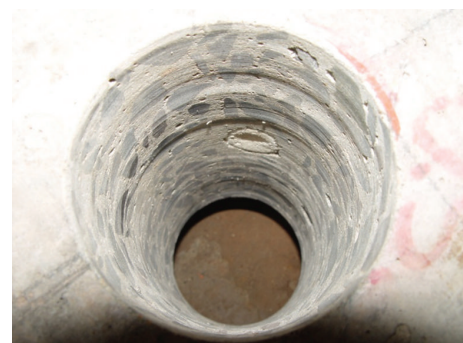
FIGURE 15: Core samples showing the Styrofoam ball.

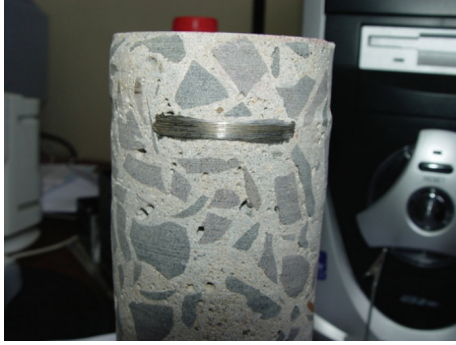
FIGURE 16: Core samples showing the piece of prestressing tendon.
