Experimental analysis of jet slurry erosion on martensitic stainless steel

To cite this article: G Santacruz *et al* 2019 *IOP Conf. Ser.: Mater. Sci. Eng.* **659** 012077

G Santacruz¹, A S Takimi¹, F Vannucchi de Camargo^{1,2}, C P Bergmann¹

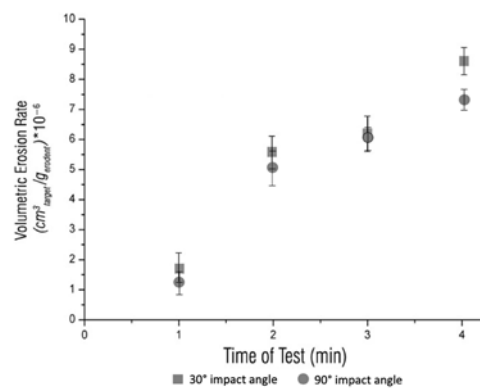
**Figure 6.** Variation of the accumulated volumetric erosion rate as a function of the impact angle of for AISI 410.

Figure 6 shows the average mass losses measured in 3 samples every 1 min until a total erosion time of 4 minutes for the impact angles of 30° and 90° . Steel exhibits a much higher erosive wear at 30° impact angle than at 90° , demonstrating a ductile behavior with a ploughing-predominant material removal mechanism, as reported in the literature [20,21]. Furthermore, many authors confirm that metals present an enhanced erosion rate at lower angles [22-25]. Figure 6 also shows that, for the impact angle of 90° , the samples presented an accumulated volumetric erosion rate slightly lower than the 30° impact angle.

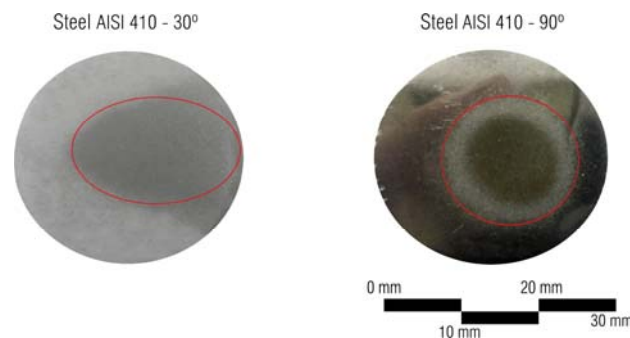
Figure 7. Areas of the eroded regions of the materials submitted to the jet slurry erosion test.

Figure 7 shows the areas of the erosion regions of the samples subjected to the jet slurry erosion test for the impact angles of 30° and 90°. It is observed that the eroded region of the pieces (highlighted in red) tested with the angle of 30° have an elongated shape and greater erosion area. The erosion of the pieces tested in the angle of 90° is more localized, has a smaller area and a greater depth. In the samples, it is possible to notice the formation of a concentric ring, described as "halo erosion" in the literature, which is a mechanical characteristic of the damage due to the development of craters that appear as macro pits on the surface for this angle [26-28]. The eroded region roughness in the samples, for the two impact angles, as shown in Table 4. Table 5 shows the areas of eroded regions according to the impact angle. It is observed that the eroded area is greater for the impact angle of 30°.

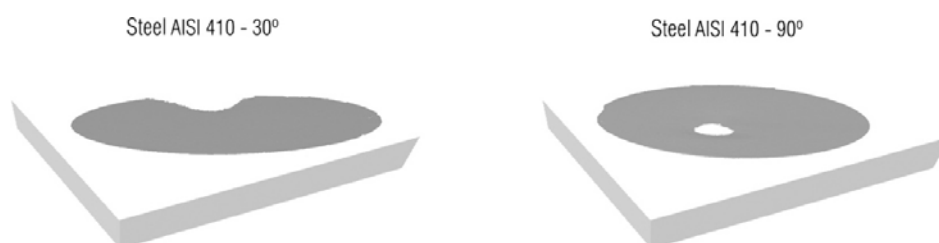
Figure 8. Three-dimensional scanning of the samples submitted to the jet slurry erosion test.

Figure 8 shows the three-dimensional scanning of the samples submitted to the jet slurry erosion test obtained through the Geomagic Studio software, for impact angles of 30° and 90°, with which it was possible to estimate the average of the erosion depth (Table 6). As result, the average erosion depth of the samples tested at 90° is higher and more localized in relation to the samples tested at 30°.
