Full Scale Testing of Fire Performance on A House Construction System Assembled With Sandwich Steel and Polyurethane Structural Panels

Luciani Somensi Lorenzi; Kássio Joe Stein; Luiz Carlos Pinto da Silva Filho.

Universidade Federal do Rio Grande do Sul, Laboratório de Ensaios e Modelos Estruturais (LEME), Avenida Bento Gonçalves, CEP 91509-900 - Porto Alegre, RS, Brasil.

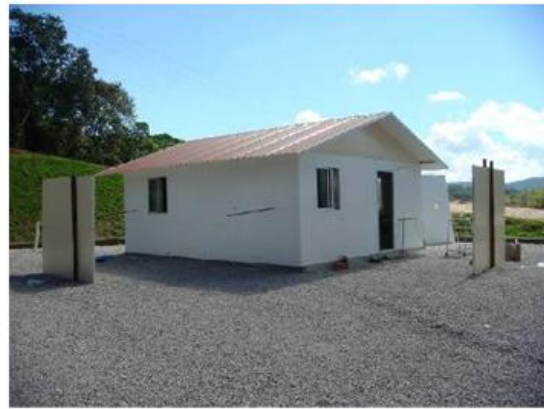
Three barriers were built 3 m away from the outside walls of the prototype, with the objective of providing protection to the team collecting data, and to simulate the presence of neighboring buildings.

The barriers were constructed with the same material of the prototypes and instrumented to collect data about the levels of temperature at the surface of neighboring buildings as illustrated in Figure 1.

Fig1. General view of the prototype.

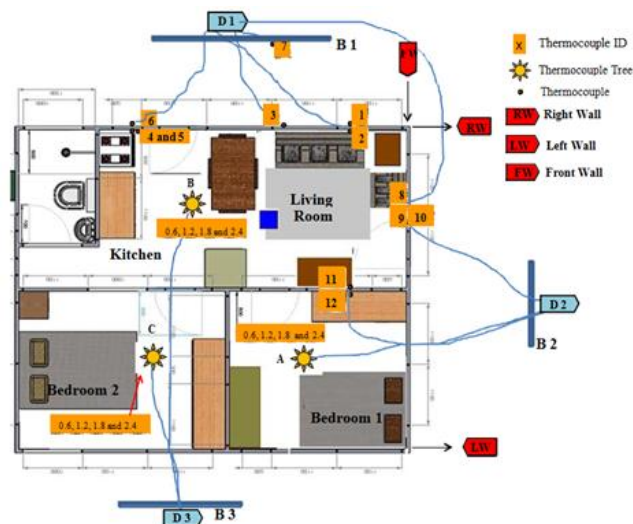
Twelve thermocouples were positioned as three trees that measured the heat in different heights; one tree located in each of the prototype's extended-stay rooms (kitchen and bedrooms).

The heights of each thermocouple located in each tree were 0.6, 1.20, 1.80, and 2.20m, and each tree was able to record 12 temperature measurements. The other thermocouples were placed on the internal and external surfaces of the wall and one was placed at the window closer to the start point of the fire. An accurate scheme of the placement of each thermocouple can be seen in Figure 3.

Fig3. Thermocouple and measuring station locations.

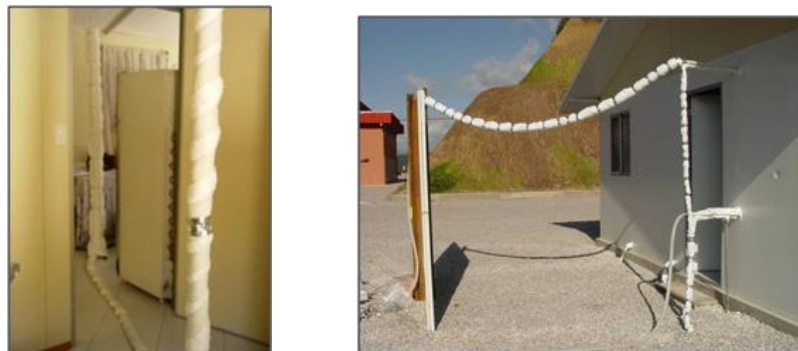
An example of the thermocouple trees can be seen in Figure 4b, which shows an internal view

of the prototype with the thermocouple trees C (front) and B (back) in display.

Fig4. Instrumentation - (a) gas collectors located close to the B2 barrier; (b) thermocouple trees inside the prototype.

The five internal gas collectors were metallic or ceramic tubes connected to suction bombs used for aspirating the gases, the locations of these collectors is shown in Figure 5 and an example

of them can be seen in Figure 4a. Three external gas collections were also placed near the B1, B2 and B3 barriers.

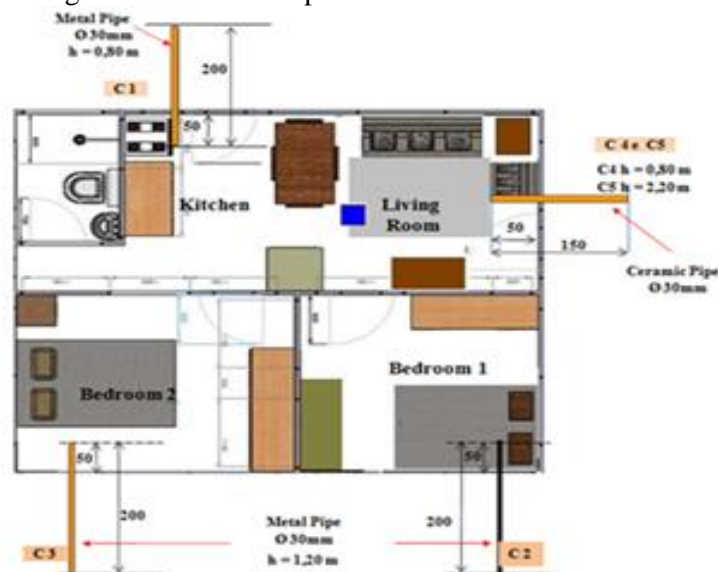
Fig5. Distribution and location of gas collectors.

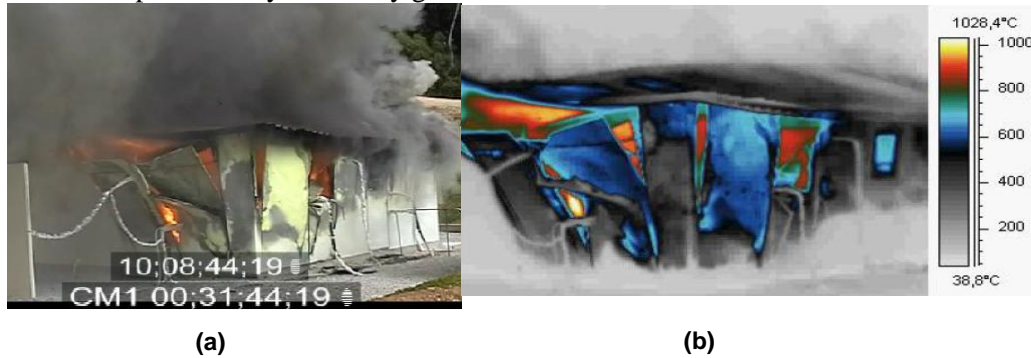
Fig6. Prototype after collapse: (a) camcorder view e (b) thermograph view.

The time of the end of the test was 10:08 a.m. and it was characterized by the collapse of the structure, 31 minutes after starting the test. Images of this moment are shown in Figure 6. During the test, some important events that occurred must be described. The wind registered on the day of the test was from north and northeast with speeds ranging from 4.0 to 6.0 m/s. The wind affected directly the results of the test, since the smoke generated by the fire was carried to the south side of the prototype (close to the B3 barrier). Visible flames decreased and the fire seemed too died out 6 minutes after the beginning of the test. The data indicates that at

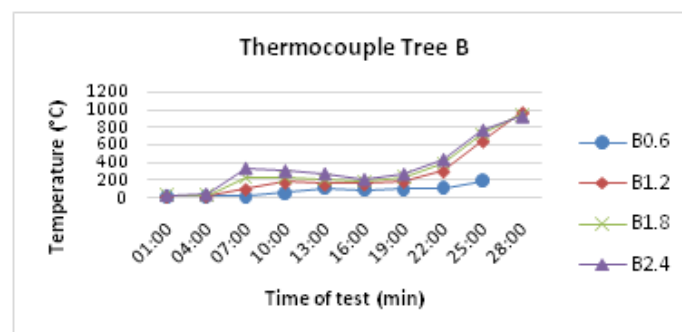
Internal temperatures were also monitored throughout the test, with data collected at every second from the start of the test until 28 minutes later, when the data loggers and computers were removed to prevent damage. The temperatures in each of the thermocouple trees during the test can be observed in Figures 7, 8, and 9.

Fig8. Temperatures collected by the thermocouple tree B.

At the beginning of the test, the average temperature assessed from the twelve thermocouples positioned at the center of each of the extended-stay rooms was 22°C. Approximately seven minutes after the start of the ignition process, the temperature in the living room/kitchen (tree B) was about 230% higher than the average temperatures measured in bedrooms 1 and 2, located 1.20 m away. Throughout the test, the higher the thermocouple was positioned, the higher was the temperature recorded, as expected. The temperatures recorded by the thermocouple tree B, located in the kitchen/living room showed that the temperature of 900°C was reached by every functional thermocouple by the end of the test, regardless of the height of the sensors. The internal thermocouples, located in different

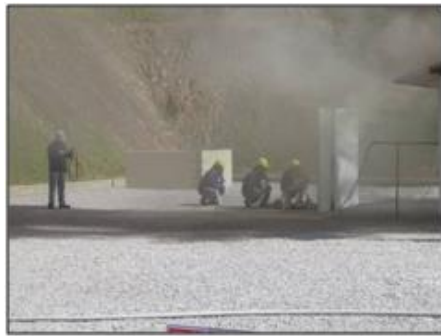
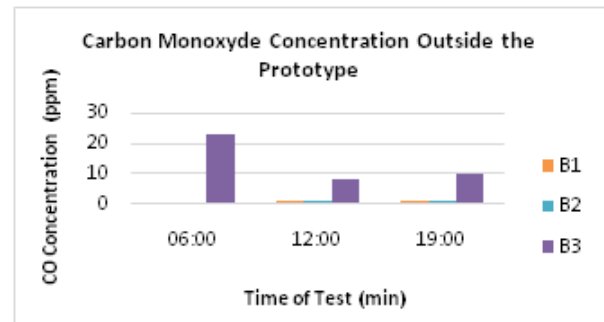
collection was performed by technicians protected by the barriers in 6-minute intervals, as shown in Figure 14.

Fig14. (a) Collection of external gases near the barrier B3; (b) Concentration of carbon monoxide at external environment.

In the three samples, the oxygen concentration remained relatively stable and above 20%. Carbon monoxide presented a small variation and its maximum concentration was recorded during the third collection at the B1 barrier (23 ppm). These concentrations do not endanger the neighborhood.
