Effect of Artificial Aging on Polymeric Surge Arresters and Polymer Insulators for Electricity Distribution Networks

Abstract: A study was conducted to evaluate new and laboratory-aged samples of surge arresters and anchorage polymeric insulators, for 12 and 24 kV networks, which are used by the Rio Grande Energia (RGE). Power Utility Polymeric compounds were analyzed by Differential Scanning Calorimetry (DSC), Thermogravimetric Analysis (TG), Dynamic-Mechanic Analysis (DMA), Fourier Transformed Infrared Spectroscopy (FTIR) and Scanning Electronic Microscopy (SEM) to verify changes in the insulator properties due to degradation occurred during the experiments. The analyses were carried out before and after 6 months of aging in laboratory devices (weatherometer, 120 °C, salt spray, immersion in water). After the aging experiments, high-voltage electrical tests were also conducted: a radio interference voltage test and, simultaneously, the total and the internal leakage currents were measured to verify the surface degradation of the polymeric material used in the housing. The impulse current test was applied with current values close to 5, 10 and 30 kA, in order to force an internal

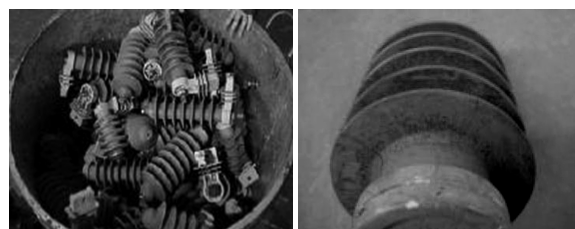
Figure 2. SR surge arresters and insulators with problems taken from the field.

The new samples and samples removed from the field are displayed in Figure 1 and Figure 2 respectively. Some studies have been carried out on silicone rubber used in the housing, obtained in the same way and subjected to the same aging conditions as the surge arresters. A, B, C, D and S denotes the different sample suppliers.

Surge arresters removed from the field due to problems also presented high leakage current. This may be due to the presence of films of water on the surface of the surge arrester silicone housings. However, it is necessary to emphasize that, considering the results of the visual inspections, the housings presented a good degree of hydrophobicity. The values for the external leakage currents under fog were higher than those under rain, with a performance similar to that observed for polymeric insulators. The values obtained were higher under fog conditions and substantially higher than under dry conditions. The external leakage currents under fog conditions reached maximum values of 700 to 1196 μA.

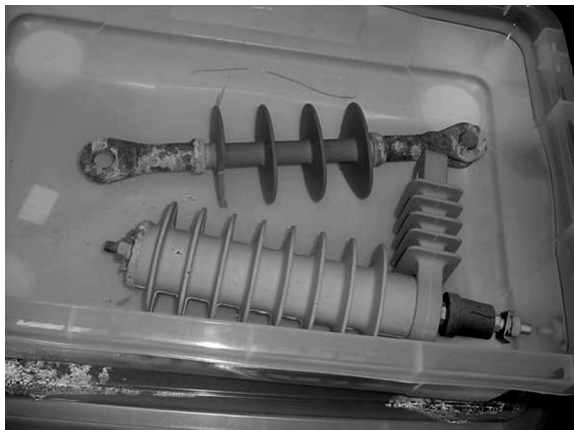
Figure 3. Samples immersed in water at room temperature.

Figure 3 shows the new samples during immersion into water at room temperature for 6 months.

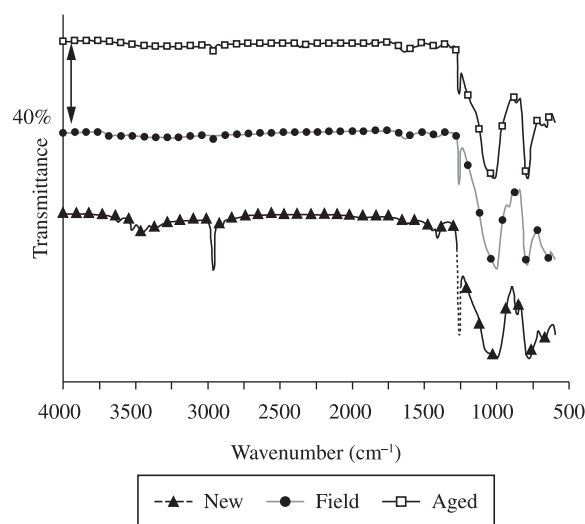
Figure 6. FTIR spectrum for the surge arresters new, 6 months of aging in salt spray end surge arresters with 4 years in the field.

The Figure 6 shows the spectra obtained for samples of SR identified as new aged (salt spray) and removed from field.

Absorption was observed in the region of 3300 to 3600 cm^{-1} , resulting from OH groups of the alumina trihydrate (ATH) present in the silicon rubber. There was a reduction in the intensity of these bands in the samples aged and removed from the field when compared with the new sample. This phenomenon could be attributed to the loss of ATH filler (chalking) and scission of C-H in CH_3 bonds.

The band at 2962 cm^{-1} is due to aliphatic C-H stretching in CH_3 , and that at 1270-1255 cm^{-1} is attributed to symmetric

CH deformation of Si-CH₃. The intense absorption at around 1000-1100 cm⁻¹ can be assigned to the Si-O-Si stretching, which shows no significant alteration, indicating that the samples can recover their hydrophobicity easier, than the new samples^[18].

In the case of aged SR in salt spray and in the field, there was a great reduction in absorbance intensity of bands originated from Si-CH₃ and CH₃ vibration compared with new samples spectrum^[19].
