# Slope stability analysis at highway BR-153 using numerical models

An existing cut slope on Highway RS-471/BR-153 is studied. The slope is composed of the Serra Geral Formation's material: a highly altered volcanic breccia and above it a slightly altered and very fractured rhyolite. A numerical analysis of the slope is carried out in two dimensions. Fracturing of the rhyolite necessitates the use of a constitutive model for materials with families of discontinuities (Ubiquitous-joint). To simplify the analysis of the problem and to examine some of the most sensitive variables, two more analyses are made, replacing the initial model by a Mohr's constitutive model, which considers the material as continuous. The results obtained from the Ubiquitous-joint model provide an acceptable representation of the field conditions, showing a failure mechanism type of rockfall from the face of the slope in the rhyolite, and the rupture surface of the breccia, without propagation of surface failure. In the analysis, when considering both materials as continuous, it is not possible to take account the fault conditions simultaneously, and this analysis also requires values of the mechanical param

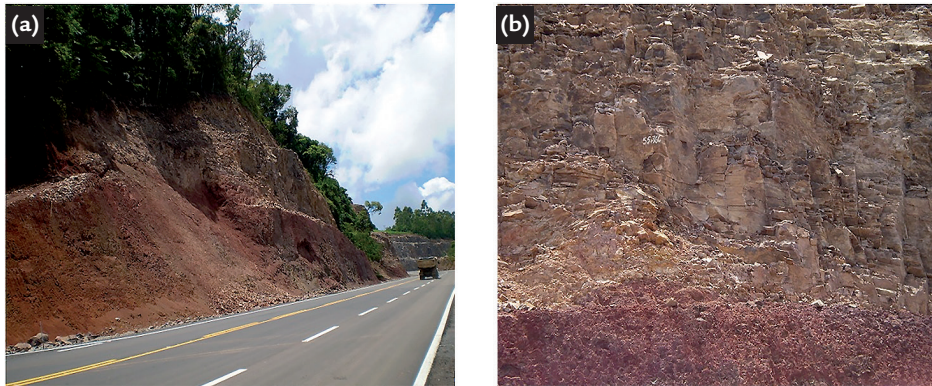
Figure 2  
(a) Overview of the studied slope.  
(b) Fracture condition on the rhyolite layer.

(see Figure 2). The rhyolite layer has a low degree of weathering, but a high level of fracturing (5–50 fractures/m). This situation is currently causing constant rock falls (Varnes 1978; Cruden and Varnes 1996). No global rupture has been observed, at least in this slope.

The distribution of displacement vectors presented in Figure 7 confirms the main source of rock particle falls, which are deposited on the lower part of the slope as well as on the highway (see Figure 2b). There exist a few points

namely, continuity of stresses above and below it. The highest levels of tension arise at the foot of the slope, reaching yielding levels in the breccia and causing local rupture of the material (see Figure 2a).

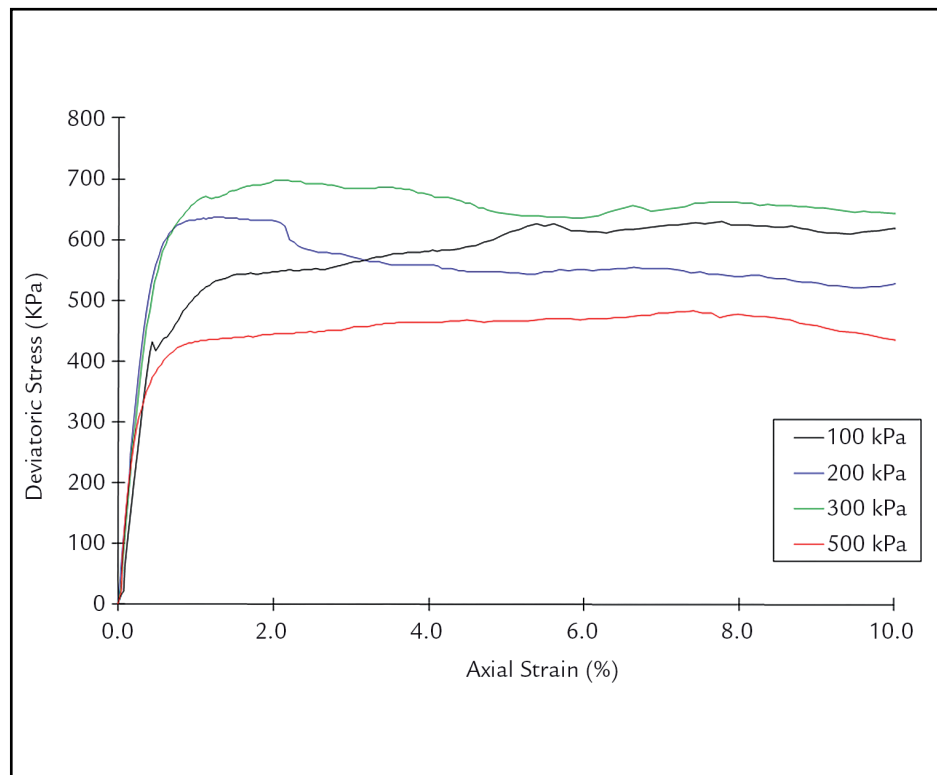
Figure 3  
Deviatoric stress versus axial strain for k55+340 (LMS-UFRGS 2004).

the angles of friction and the cohesion were estimated from the results of CIU triaxial tests, made in undisturbed test bodies (see Figure 3).

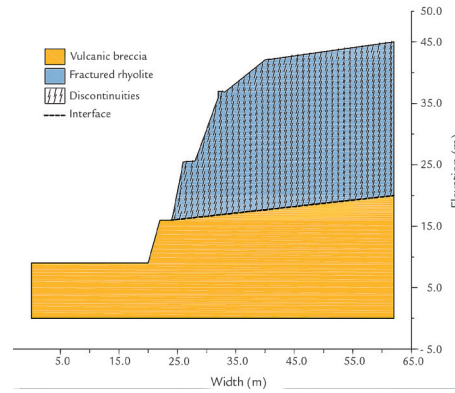
Figure 4  
Model of the evaluated section.

Figure 4 presents the model to be evaluated, including the system of discontinuities of the rhyolite. For the analyses ignoring the presence of discontinuities, the geometry of the

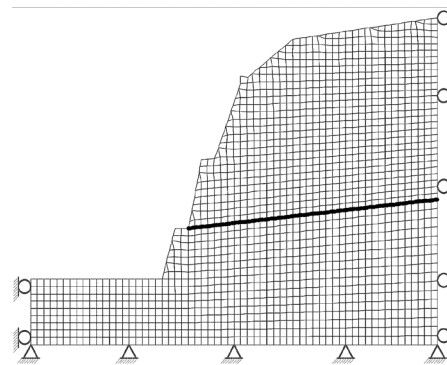
Figure 5  
Mesh of elements with fixed areas.

without discontinuities are obtained as part of the results of the simulation process. Figure 5 presents the element mesh for this analysis, as well as the boundary conditions imposed on the

model. The thick black line indicates the interface defined by the material

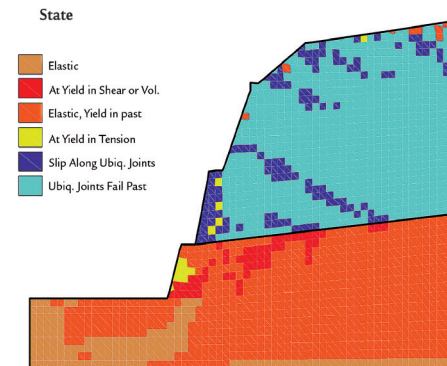
Figure 6  
States of the model (with *Ubiquitous-joint*).

rupture surfaces for continuum materials according to the Mohr–Coulomb criterion, allows visualization of the effects of ruptures associated with sliding along different discontinuities. Figure 6 presents different states for the elements of which the model is composed, enabling visualization of the elements under instability, either for the

curved surfaces of rupture (see the volcanic breccia) or for the sliding of the elements along the discontinuities. In the center of the rhyolite mass, it is also possible to observe the presence of consistent slide surfaces with the formation of alleviating tensions caused by the lateral expansion (in the lower part of the rhyolite layer).

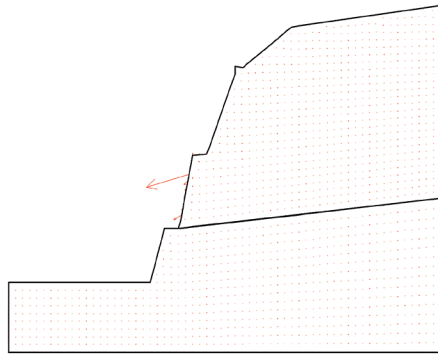
Figure 7  
Displacement vectors  
(with Ubiquitous-joint).

of origin of rock falls in the upper part of the layer, mainly caused by the slope declivity angle. The distribution of shear stress presented in Figure 8 is consistent with the condition imposed on the interface between the two layers,

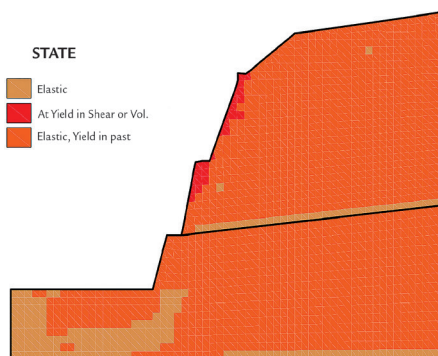
Figure 9  
States of the model  
(continuous, flat rupture).

Figure 9 shows the results of this

simulation. The properties of the breccia were not decreased, since the existence of a rupture surface in the breccia influences its propagation along the rhyolite layer. For the given angle of declivity of the slope, the angle of friction for the rhyolite given by the simulation is not consistent with any values in literature: however, it does predict shallow failures (see Figure 10). These flat ruptures retain the form predicted by a Mohr–Coulomb model, exhibiting a rupture surface curve.

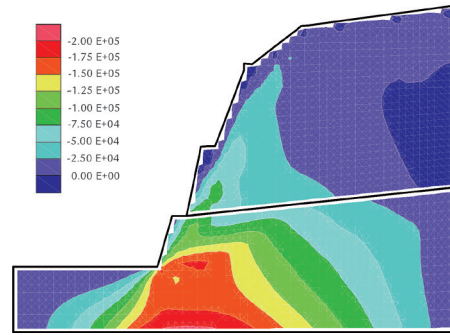
Figure 11  
Shear stress  $S_{xy}$  (continuous, flat rupture).

The distribution of shear stress presented in Figure 11 suggests a reduction

in the levels of shear stress in the areas next to the slope face, but the condition of

maximum tension at the foot of the slope is maintained.

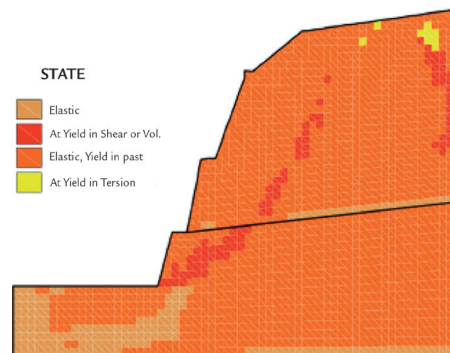
Figure 12  
States of the model  
(continuous, deep rupture).

Figure 12 presents different states of the model. No surface rupture was observed in the slope. The value for the angle of friction of the rhyolite was adopted because of the

sensitivity of this material to a rupture surface from the breccia. With this value of the angle of friction, the susceptibility of the rhyolite remained low, although it should be pointed out that it is a theoretical value, not necessarily representative of realistic situations. It can be seen from Figure 13 that it was not possible to obtain significant horizontal displacements along the slope face, confirming the absence of boulders in unstable condition, and therefore, denying the possibility of rockfalls.

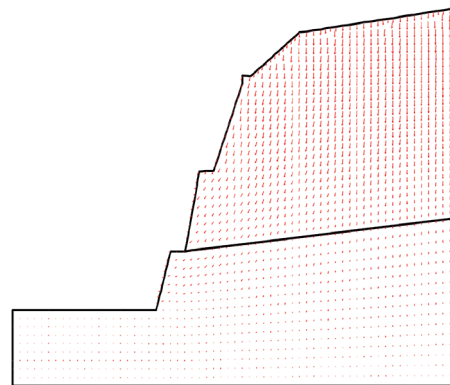
Figure 13  
Displacement vectors  
(continuous, deep rupture).
